# Performance of Thermal Insulation on the Exterior of Basement Walls

by M.C. Swinton, M.T. Bomberg, M.K. Kumaran, N. Normandin and W. Maref

**Basement problems are a frequent source of claims made under new home warranty programs. This Update presents the results of an IRC/industry research project on the performance of insulation systems applied to the exterior of basement walls.\***

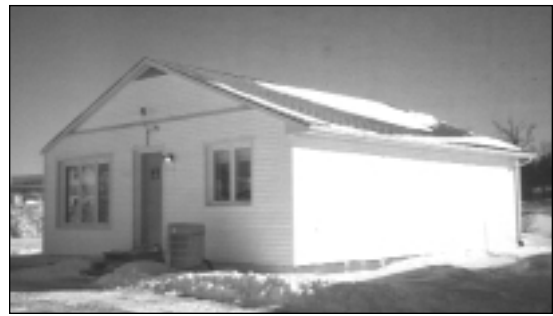
Figure 4. IRC Test House #1 with above-ground portion of basement visible

Prior to this study, designers and builders had little factual information about how the insulations they specified would perform when placed on the outside of a basement wall in contact with the earth. But IRC's continuous monitoring of the thermal performance of 13 different basement insulation systems throughout two heating seasons has provided some answers, including some understanding of how these systems manage water. The insulation systems were placed side by side on the exterior of two of the basement walls of IRC's Test House #1 (see Figure 4).

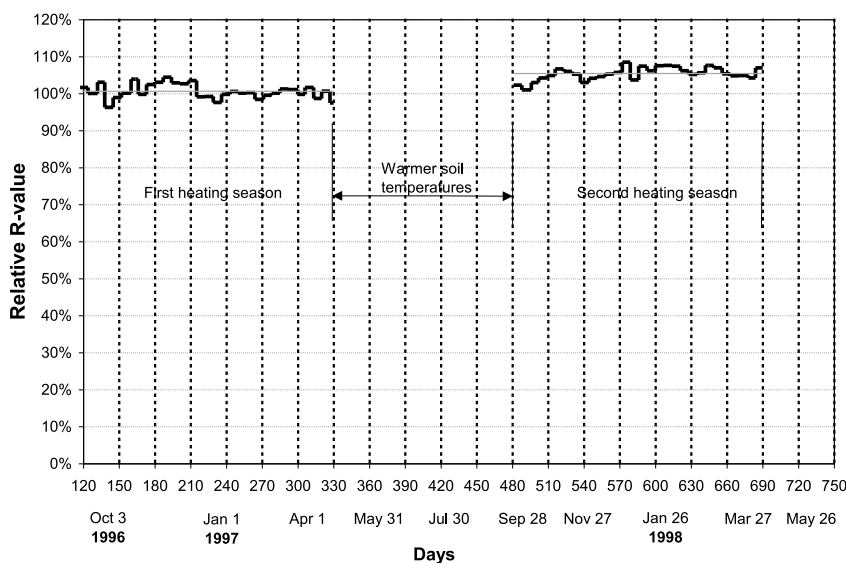
Figure 5. Typical in-situ R-value for a specimen over two heating seasons expressed as a percentage of its R-value in the initial month

(Figure 5 shows the R-value for a typical specimen). The specimens sustained their performance even during major rain storms and winter thaws, when the effects of water movement were recorded at the outer face of the insulation specimens. This result was contrary to expectations that the R-value would decline under such circumstances, especially if water were to move through the insulation.

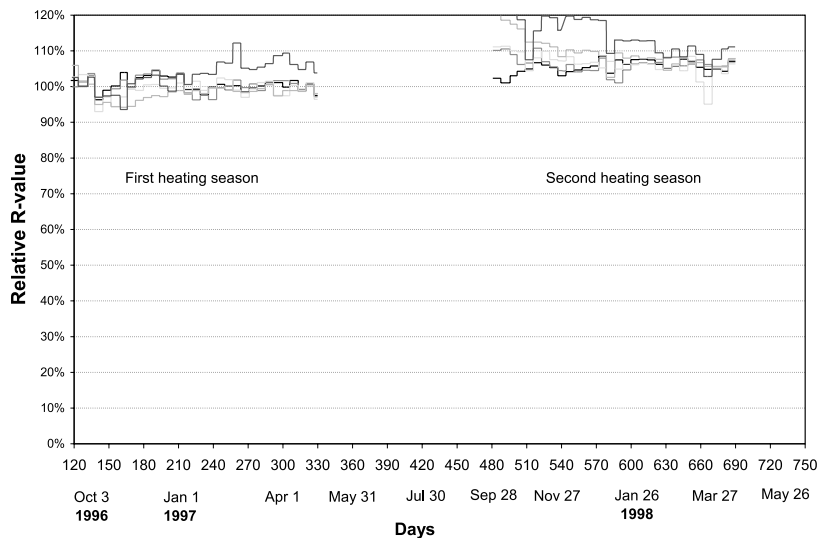
**Figure 6.** Range of results for all products assessed on one wall (EPS Type 1, EPS Type 2, glass fibre, mineral fibre and SPF)

All five insulation products assessed in the research are designed to deliver a sustained level of thermal resistance in ground, but they do so with different strategies (see Figure 6). In the figure, all R-values were referenced to their own average R-value of the first month; hence all graphs start at about 100%. The degree to which the graphs diverge from this common starting point is a measure of the difference in each product's ability to deliver sustained R-value. The figure demonstrates that all products sustained R-values very close to their starting R-values throughout the first year, and performed just as well, or even better, in the second year.

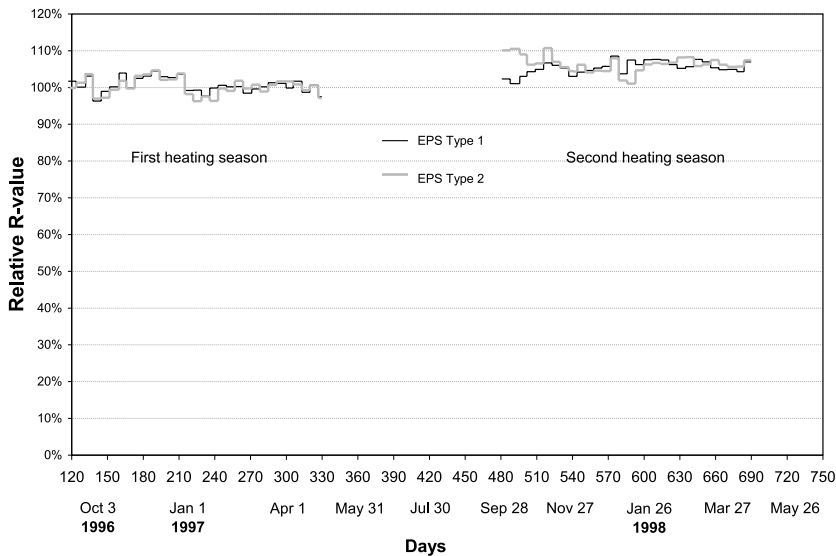
**Figure 7.** The measured performance of EPS Type 1 and EPS Type 2, which were side by side on the exterior of one basement wall, was basically the same — that is, both boards sustained thermal performance in this environment.

assessed — EPS Type 1 and EPS Type 2. Each has slightly different thermal and mechanical properties. The compressive effects of the pressure developed in the soil around basements on both boards is small relative to the compressive strength of the boards, even for the lower density product, Type 1. The two types were placed side by side to see if any performance differences could be detected. Little difference in their ability to sustain R-value was found: on average, both types delivered sustained thermal performance over the two-year period (Figure 7).

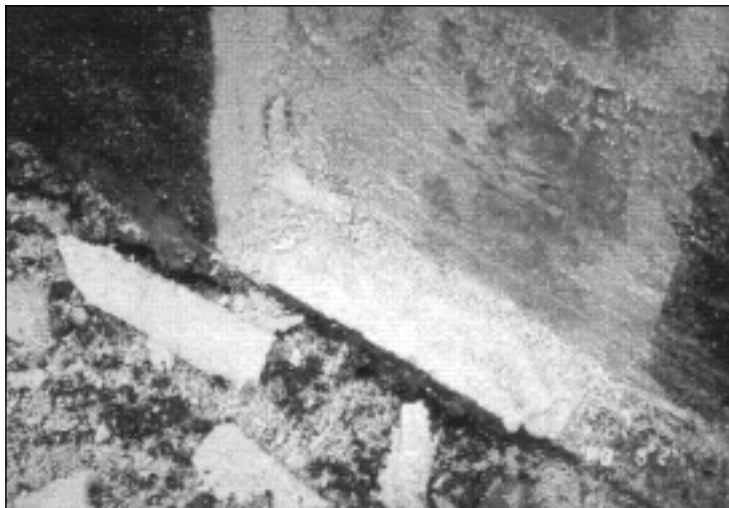
**Figure 8.** The spray-polyurethane foam bonded well to the concrete wall and footing. Remnants of the product still bonded to the concrete can be seen here.

fully bonded to the concrete, forming a continuous protective layer over the wall, footing and joint (Figure 8).
