# CASE STUDY

## Manchester Church

## Huntsman Building Solutions Spray Foam insulation for Vaulted Church Roof Restoration

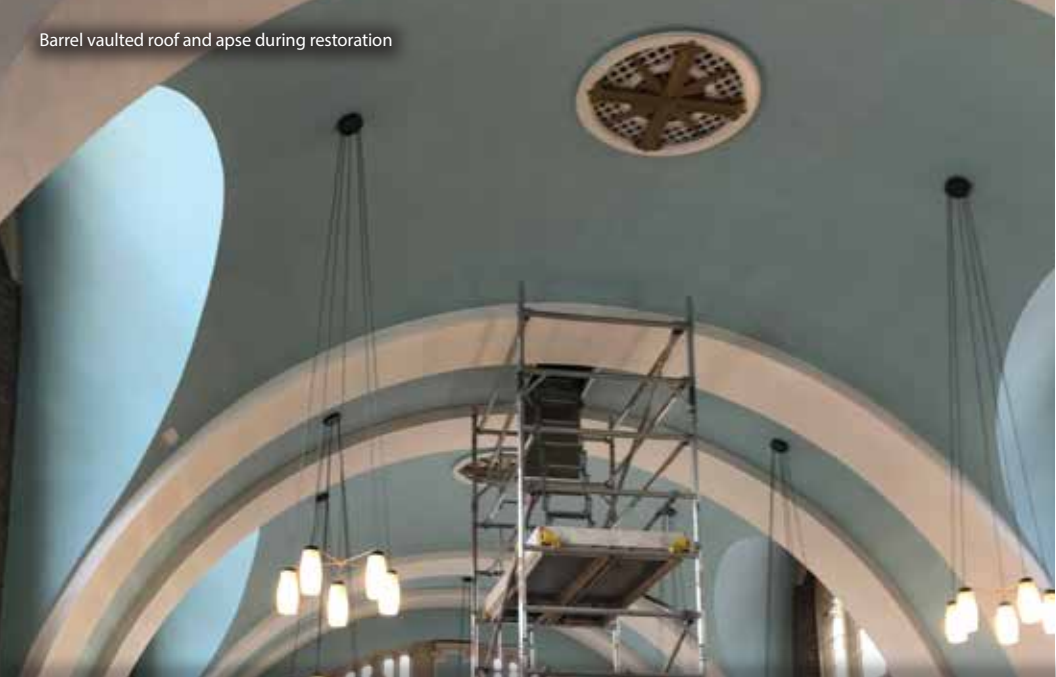
Barrel vaulted roof and apse during restoration

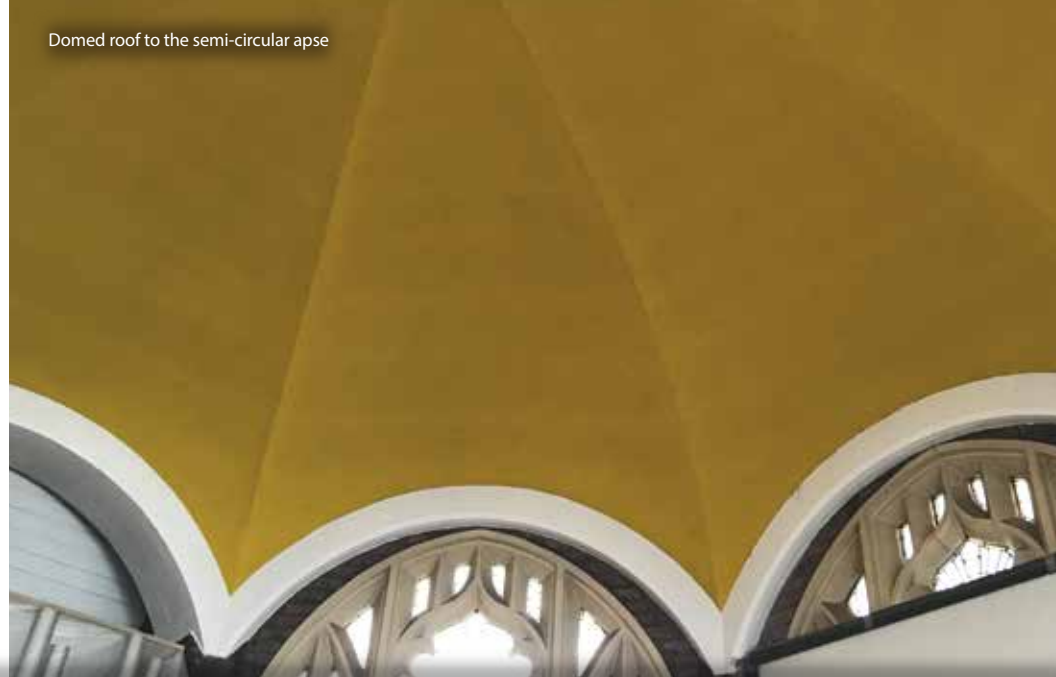
Domed roof to the semi-circular apse

could not be made to fit and we couldn’t guarantee that layers of flexible, mineral wool insulation would actually stay in place after installation. We needed an insulation material that would follow the curvature of the vaulting and fill the voids created by the complex geometry of the apse dome and roof structure above”.

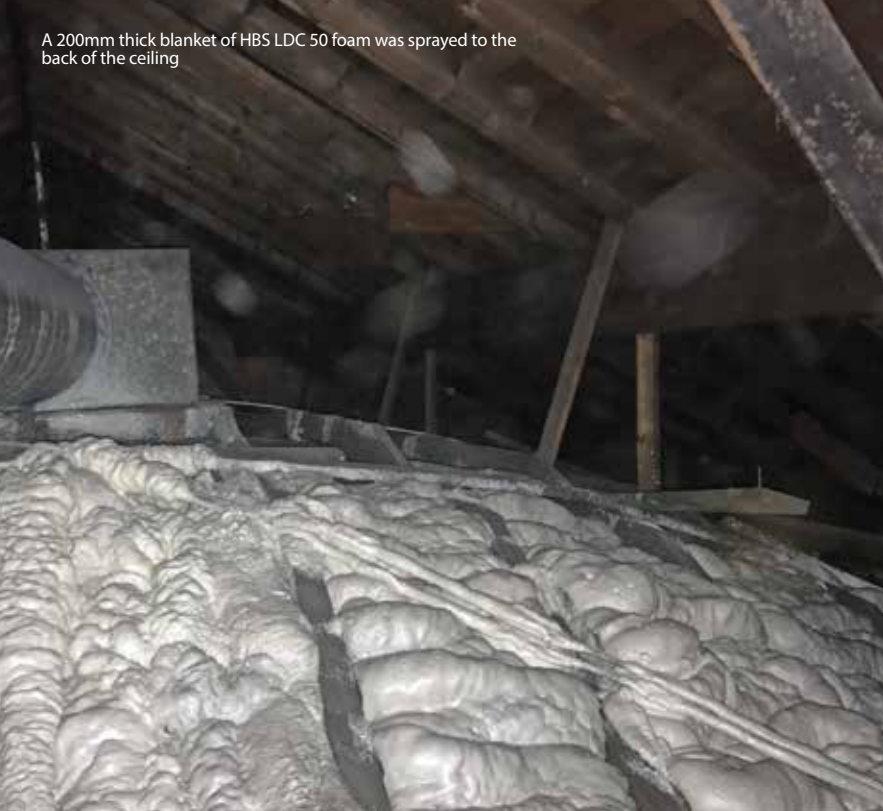
A 200mm thick blanket of HBS LDC 50 foam was sprayed to the back of the ceiling

a little as we climbed up onto the arch”. H2Foam Lite (LDC 50) insulation foam was sprayed to a thickness of 100-200mm directly on to the back of the ceiling structure. Green Horizon’s objective was to create a minimum blanket of 100mm over the entire ceiling back – roughly 450 square metres, with additional depth used to fill areas where adjoining arch planes met. Installation of the HBS insulation was completed over a seven-day period.

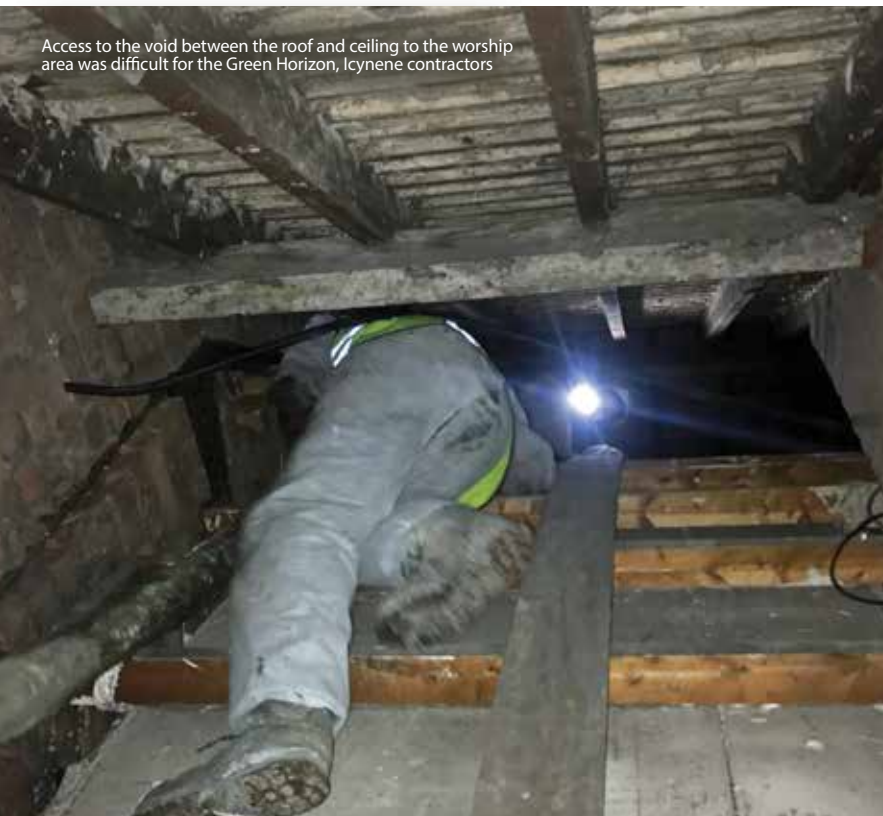
Access to the void between the roof and ceiling to the worship area was difficult for the Green Horizon, Icnene contractors

Access to the ceiling vault was one of the most difficult challenges to the insulation process, explained Matt Lawford. “We were on a very near vertical incline at the sides of the dome and had to manoeuvre across the timber roof joists, in difficult tight spaces, taking extreme care not to damage the ceiling of the church below. The workspace on the sides was only a few feet wide in places but it opened-up
