## ***In-situ Performance Evaluation of Exterior Insulation Basement System (EIBS) – Spray Polyurethane Foam Summary Report***

M.C. Swinton, M.T. Bomberg, M.K. Kumaran, W. Maref, N. Normandin,  
R.G. Marchand

Internal Report No. 820

Date of Issue: November 2000

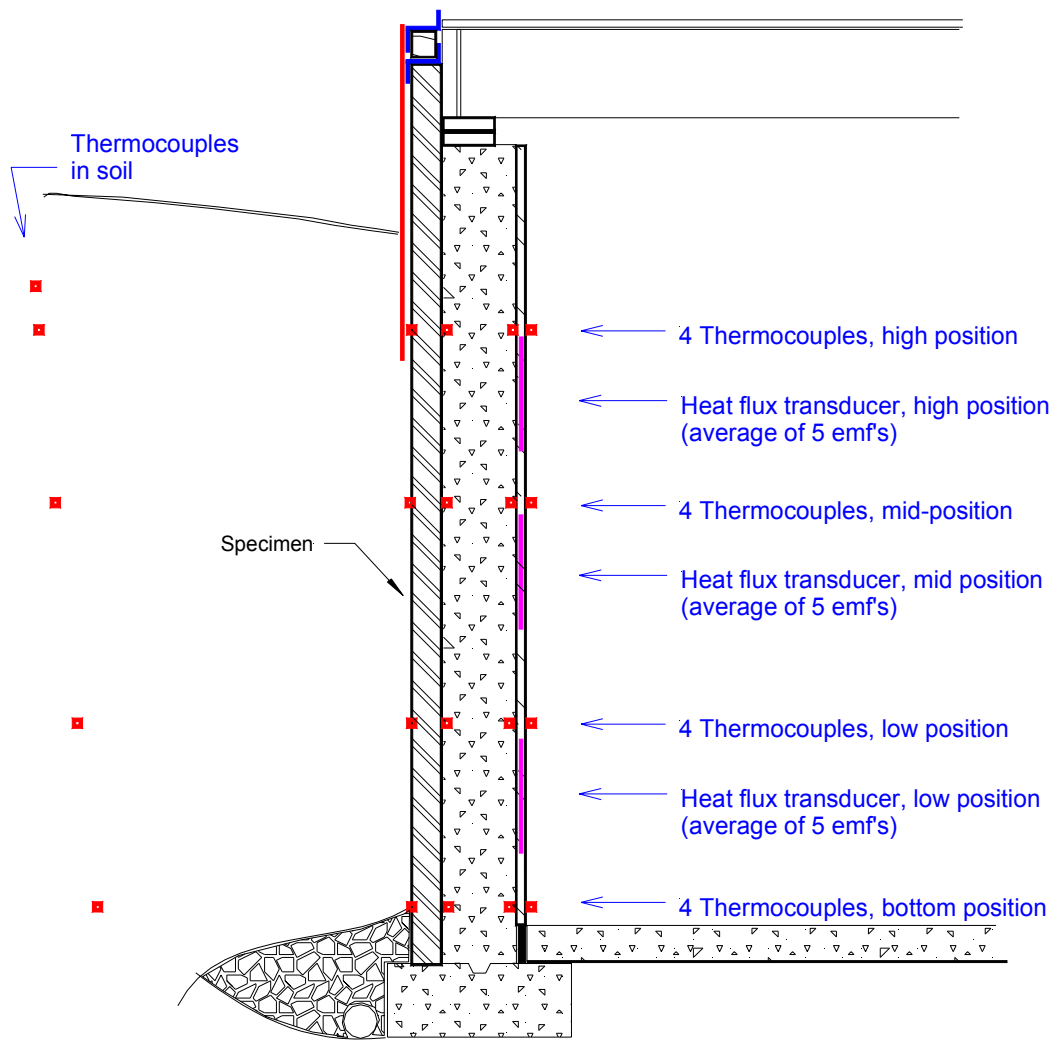
Figure 1. General Layout of Insulation Specimens and Sensors

The SPF specimens were sprayed over the full height of two 1220 mm wide segments of the exterior basement wall of Test Hut #1, at NRC's main Campus in Ottawa. Their performance was monitored using a strategy developed to monitor the in-situ thermal performance of roof insulation<sup>2,3</sup>. A thermally calibrated, 25 mm layer of expanded polystyrene board was installed over the entire surface of the interior of the basement wall. Thermocouples were systematically placed at the surface of each element in the wall, in a vertical array consisting of 16 points per specimen. A schematic diagram of this arrangement is shown in Figure 1. As well, heat flux transducers were installed at three vertical locations.

The field experiment consisted of installing an SPF specimen on each of the east and west basement wall of Test Hut #1. The specimens were instrumented as shown in Figure 1.

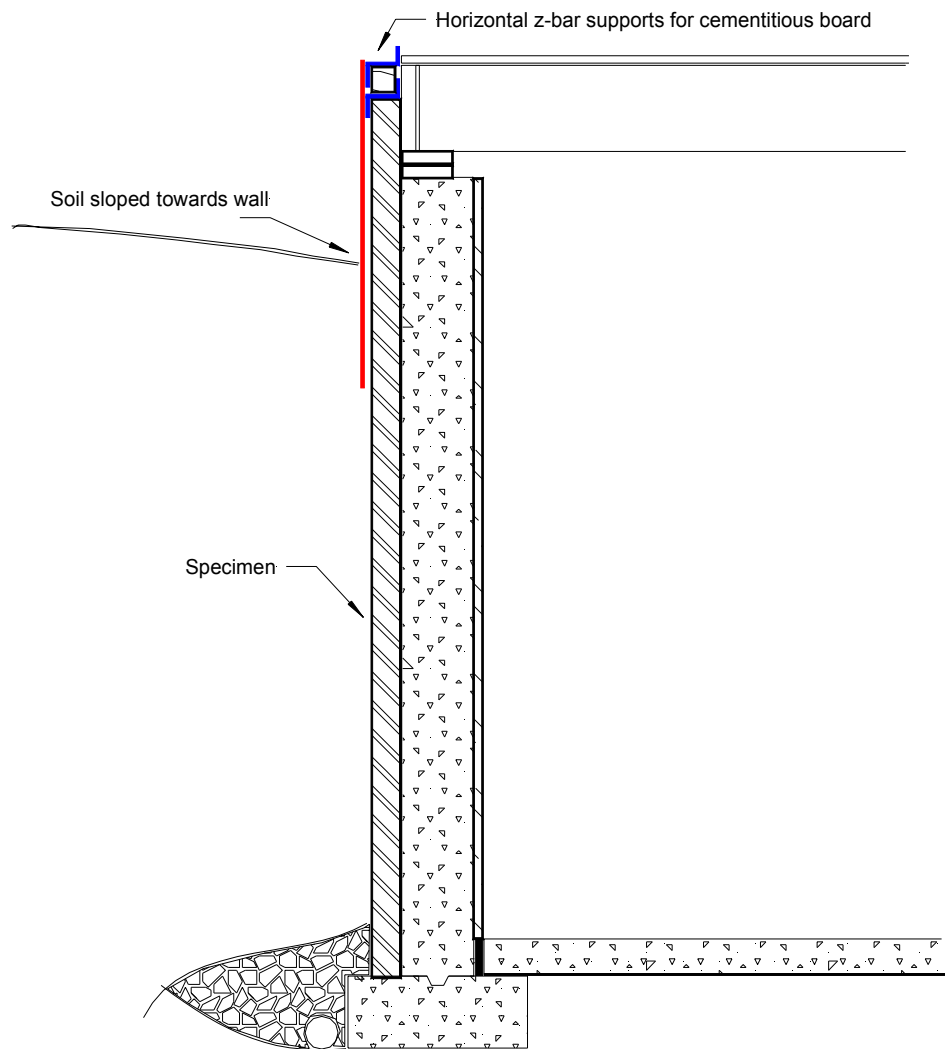
Figure 2. Installation System 1 for the Above Ground Protective Assembly - West Wall.

Two different installation methods were used on the east and west wall configurations, labelled System 1 and System 2 respectively. System 1 on the west wall (Fig. 2) featured two horizontal rows of metal z-bars, separated by a wood spacer, all fastened to the header. Once the insulation was in place, the cementitious covering boards were fastened to the z-bars and wood space. No other fasteners were used, so the cementitious board was effectively

'cantilevered' over the insulation specimens. The soil was sloped at 5% grade towards the wall, to simulate a settled condition.

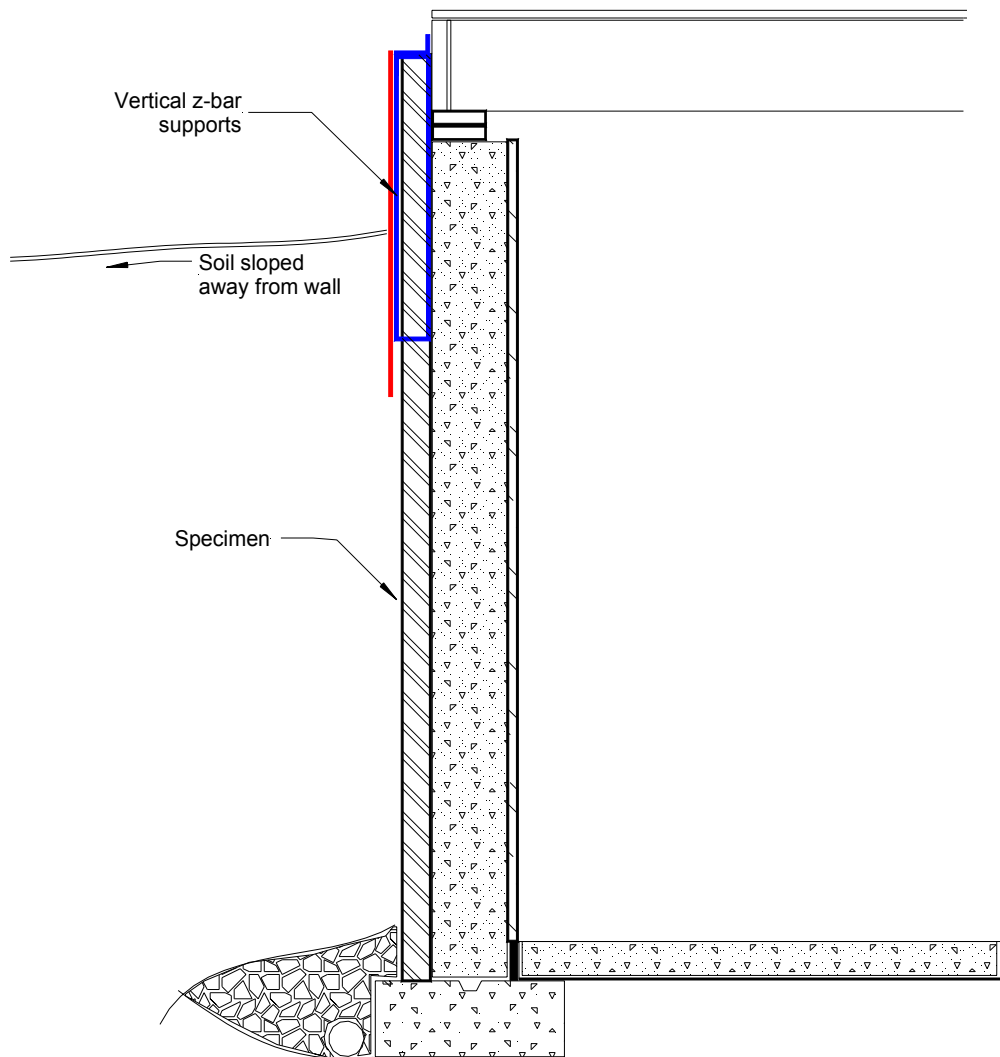
Figure 3. Installation System 2 for the Above Ground Protective Assembly - East Wall

System 2 on the east wall (Fig. 3) featured metal z-bar supports placed vertically between each insulation specimen. The z-bars were fastened directly to the concrete wall and wood header on the inside, and fastened to the cementitious board on the outside. Each metal z-bar was therefore a thermal bridge around the insulation. System 2 also featured an initial 5% sloped grade away from the basement wall.

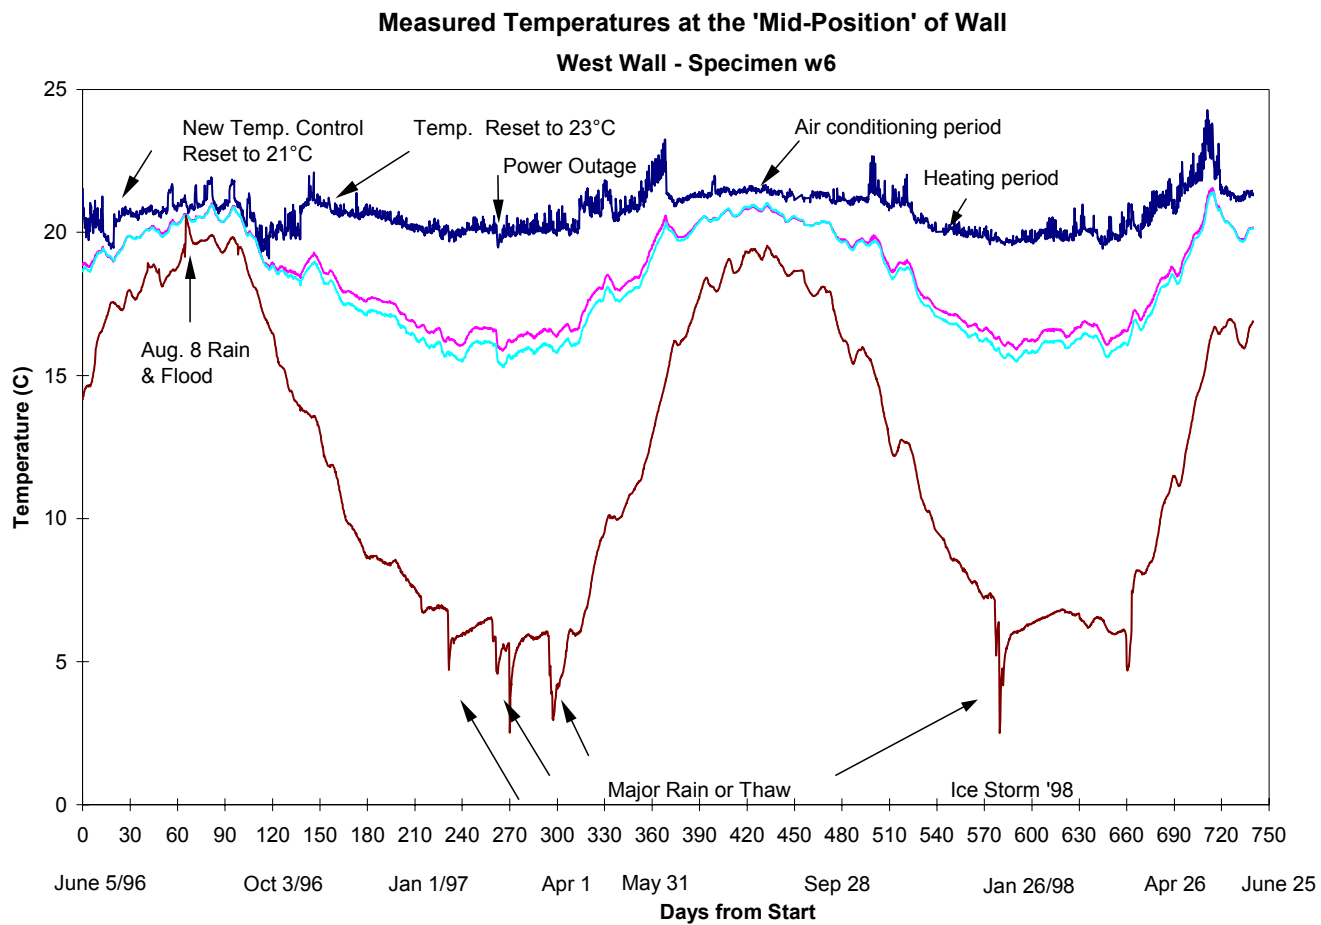
**Figure 4. Temperature Profiles at the Mid-Position of Specimen W6 on the West Wall**

Figure 4 shows the two-year temperature record at four locations through the wall at specimen W6: the interior surface, both sides of the concrete, and the exterior surface of the specimen in contact with the soil. The inner surface of the wall is kept near 21°C, with small variations throughout the two years. Main control events such as power outages and changes from heating to air conditioning and back are evident from these temperature readings. The temperature at both sides of the concrete are quite close to one another (concrete being a poor thermal insulator), and these vary from 15°C to 20°C, from winter to summer.

The lowest curve in the graph is the temperature record for the insulation/soil interface. These vary between about 5°C in winter up to a maximum of about 20°C in summer.

The periodic 'spikes' in this curve correspond to recorded events of heavy precipitation or winter thaws. The August 8, 1996 rain was a 1 in 75 year event for Ottawa, which caused local flooding around the test hut. During this storm, the temperature at the insulation/soil interface deflected upwards, apparently due

to warm rainwater moving down the wall. Such deflections were observed at the mid, low and bottom thermocouple positions during the same period, tracing the path of the water. These deflections were much less noticeable at the high position, where the soil temperature would be closer to the temperature of the moving water.

The temperature deflections in the winter at the soil/insulation interface are downward because the melt water temperature is initially 0°C, which cools the soil and insulation at the interface.

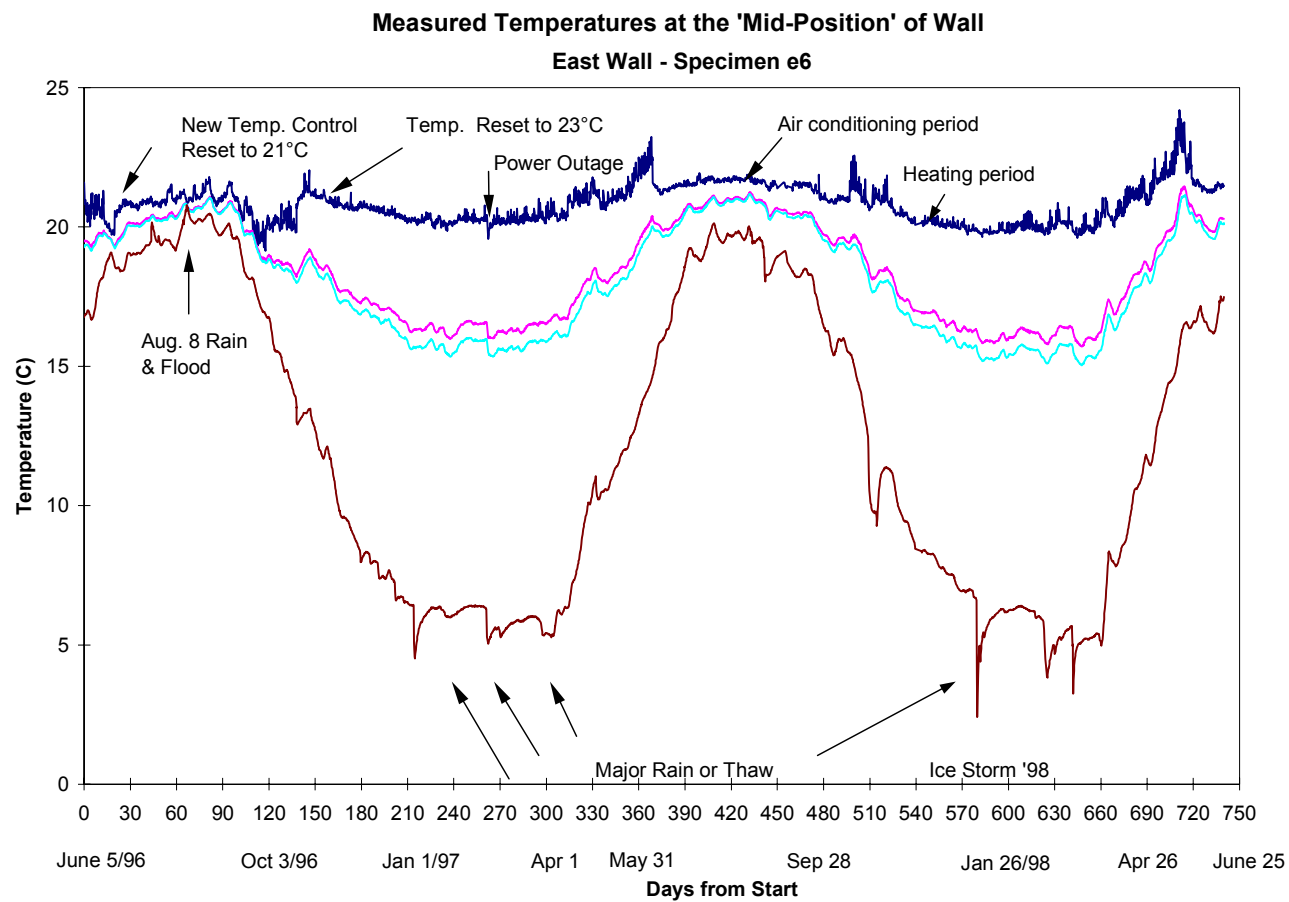
**Figure 5. Temperature Profiles at the Mid-Position of Specimen E6 on the East Wall**

Figure 5 shows temperature measurements on the east wall of the test hut for the same insulation product that was shown on the west side in Figure 4. In the first year, these periodic temperature deflections were often smaller or absent on the east wall where the ground surface was properly graded outward. This relative absence of temperature deflections can be observed in Figure 6 for the first winter.

In the second year however, the differences between east and west were less noticeable, and the temperature deflections were then quite noticeable. A final review of soil slopes near the wall revealed that by the end of the second year, most of the slopes had settled on the east wall. These slopes were now mostly inward.

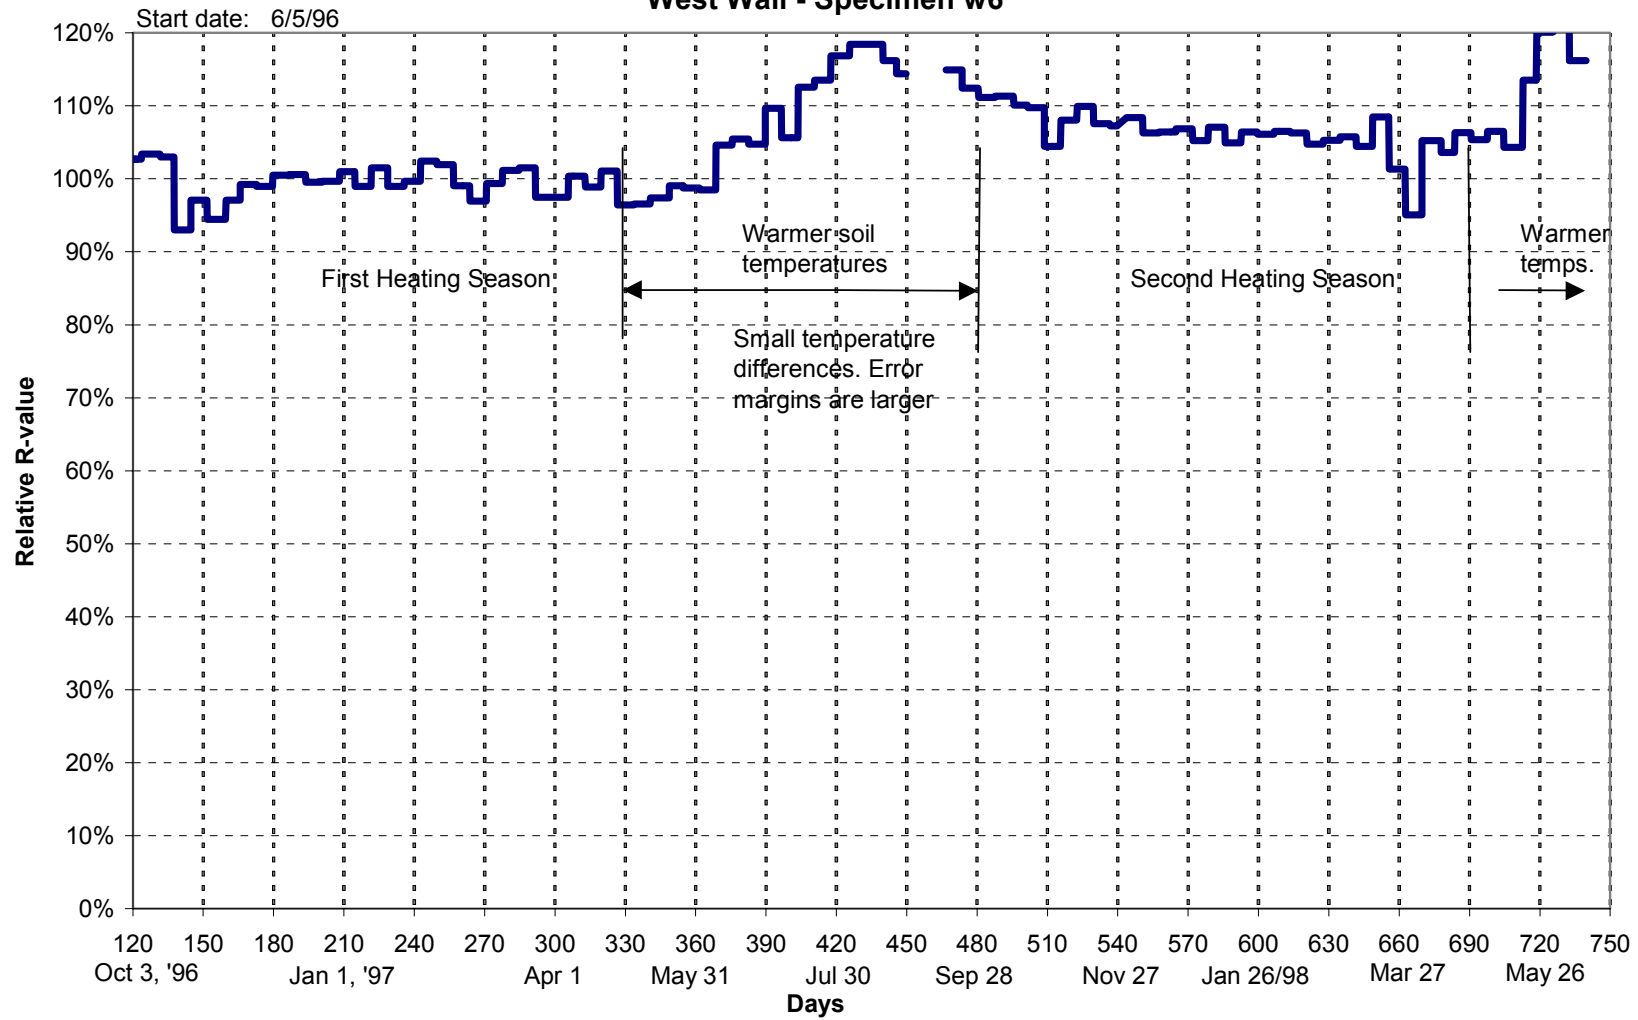
# Weekly Average R-value of the Specimen Relative to the R-value for October 1996

## West Wall - Specimen w6

Figure 6. Trend in R-value for Two Heating Seasons.  
(Normalized to Initial R-value for October 1996)

Figures 6 and 7 show the resulting thermal performance plots for the specimens on the west face (a) and the east face (b). The change in thermal resistance adjustment is shown on a weekly basis over two heating seasons. Key observations are as follows:

- all specimens show relatively steady performance through the heating seasons
- the second heating season shows equal or improved performance for all specimens
- the results for the warm periods are unreliable, since the temperature difference across the specimens are very small ( $< 0.5^{\circ}\text{C}$ ). During such periods, thermocouple errors can be as large as the actual temperature difference.
- On day 215, modifications were made to faulty controls on the sump pump. Water levels around the footing were lowered over time. The sump pump connection is nearest specimens W5 & W6.
- Major rain and thaw periods do not appear to significantly affect the thermal performance of the specimens during these episodes.

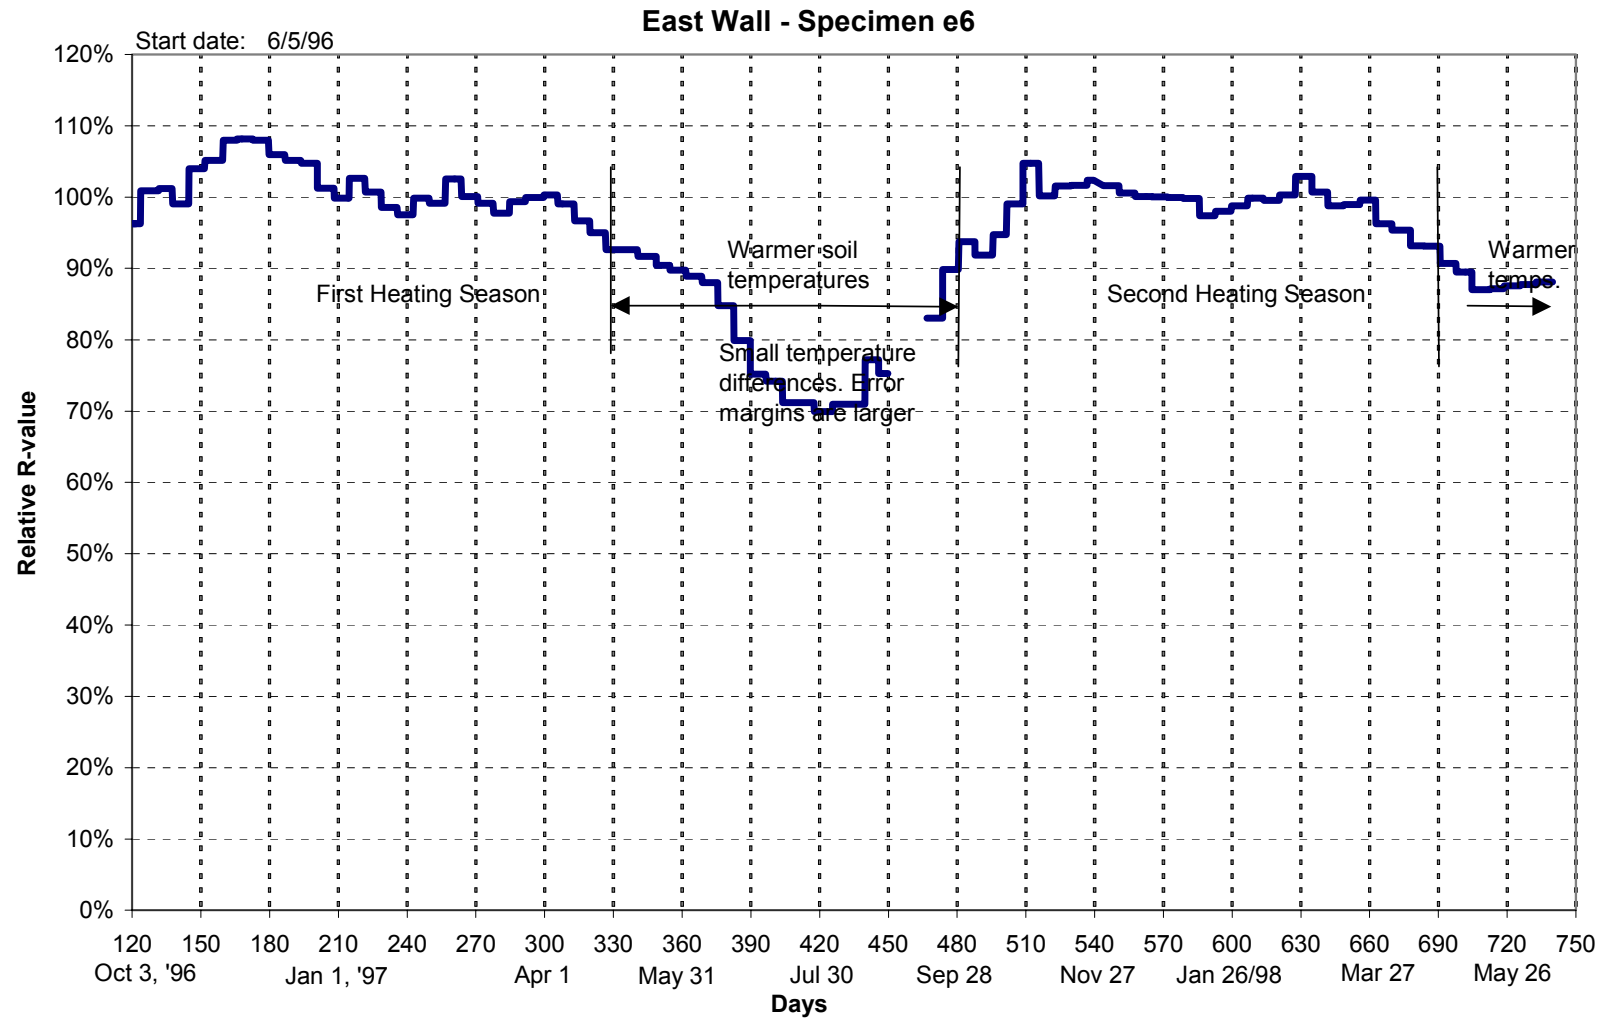
# Weekly Average R-value of the Specimen Relative to the R-value for October 1996

Figure 7. Trend in R-value for Two Heating Seasons.  
(Normalized to Initial R-value for October 1996)
