Case Study

Basement Flooding

Product:
Heatlok Soya
Closed Cell Spray Foam Insulation

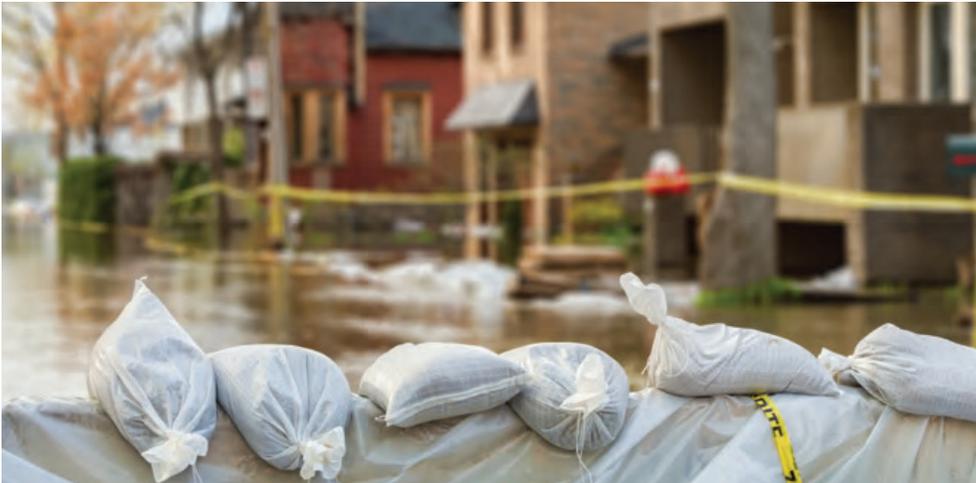
On May 22, 2017, following the river flooding in the spring, HBS visited a flooded basement with 4' of contaminated water (photo 1). The basement was insulated entirely with Heatlok Soya closed-cell spray foam. The purpose of this visit was to check the condition of the foam insulation after 5 days of immersion. The contaminated water was mixed with sewage and oil spillage.

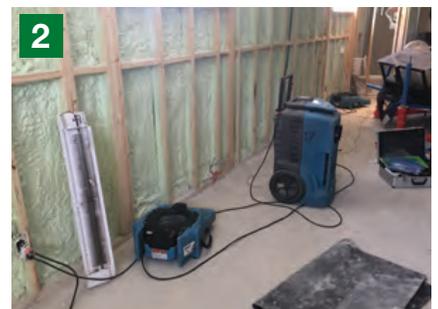
Prior to the visit, the surface of all the walls had been washed and the basement had been cleaned with a pressure washer. Dehumidifiers and industrial fans had been in operation for 5 days (photo 2). In order to verify the effects of the flooding on the spray foam insulation, samples were taken on site for laboratory testing. Readings of the moisture content in the wood were made in several places (photo 3).

Even after being submerged for several days, the spray foam insulation was dry and showed no signs of deterioration. Water absorption and mold growth were not an issue. The uncovered wood dried with the help of dehumidifiers and fans. However, the portion of the wood studs embedded in the polyurethane were still moist.

The existing spray foam insulation may remain in place, but the drying of the wood must be facilitated with industrial equipment. It is important to thoroughly clean the joints between the wood structure and the floor to allow the wood to dry out as quickly as possible. The wood must reach a moisture content of less than 19% in order to allow the installation of finishing panels.
